สถาบันวิจัยแสงซินโครตรอน (องค์การมหาชน)  
Synchrotron Light Research Institute (Public Organization)  
เอกสารความรู้ (knowledge documents)

หมายเลขเอกสาร(For QDS) KM Document No.	SLRI-TN-2025-176
ชื่อเรื่อง Title	Maintenance of Kohzu's double-crystal monochromator when electrical failure
ชื่อฝ่าย Department	ฝ่ายระบบลำแสง
วันที่เผยแพร่ Release date	21 พฤศจิกายน 2568
ระดับการเปิดเผยข้อมูล Level of Disclosure	<input type="checkbox"/> ข้อมูลในรายงานเป็นความลับ (Undisclosed) <input type="checkbox"/> เปิดเผยข้อมูลเฉพาะภายในฝ่ายหรือส่วนงาน (Information can be disclosed within department/section) <input type="checkbox"/> เปิดเผยข้อมูลได้สำหรับพนักงานของสถาบันฯ และอนุญาตให้บันทึกข้อมูลเข้าเป็นส่วนหนึ่งของระบบ Knowledge Management ภายในสถาบันฯ (Information can be disclosed for SLRI staffs and can be part of SLRI's Knowledge Management System) <input checked="" type="checkbox"/> เปิดเผยข้อมูลได้เพื่อเป็นองค์ความรู้สาธารณะ เช่นเว็บไซต์ของสถาบันฯ (Information is available for public)
คำสำคัญ Keyword	Double Crystal Monochromator, DCM, Electric failure, Beamline 7.2W:MX, Kohzu

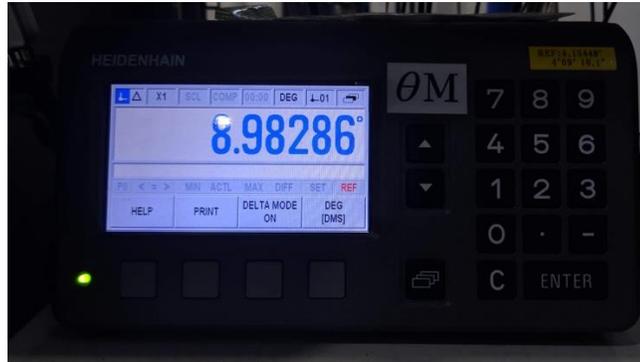
Figure 1 The encoder for DCM shows Bragg degrees in corresponding to photon energy

According to the encoder having reference number provided by Kohzu at  $4.15448^\circ$ , however at this status of DCM offset, it is acknowledged by Dr.Yuji of Kohzu on site that our reference number is  $4.15387^\circ$ . It is necessary to perform calibration on the encoder and DCM for correcting position of main theta angle in steps as following:

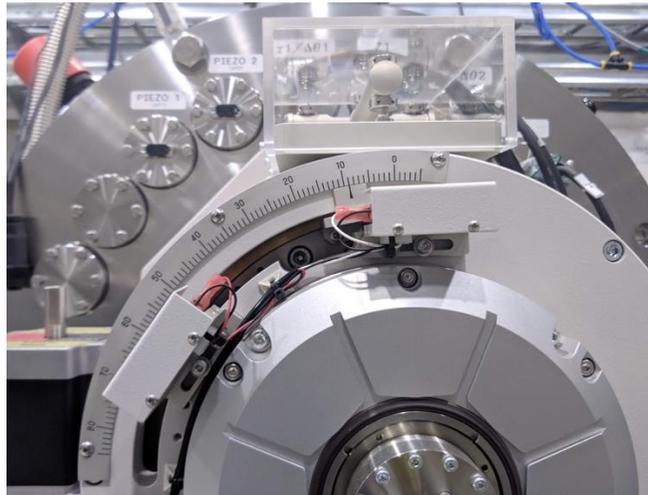
Figure 2 A number of main theta on the DCM within in BL7.2W in correlating to the encoder

All parameters of the encoder and handy controller were recovered and corresponded to the previous parameters before the electric fault.

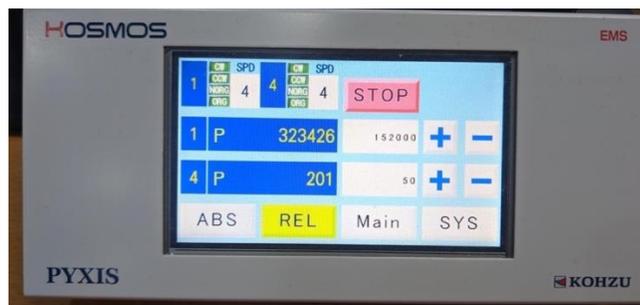
Figure 3 The handy controller for DCM in order to manually adjustment

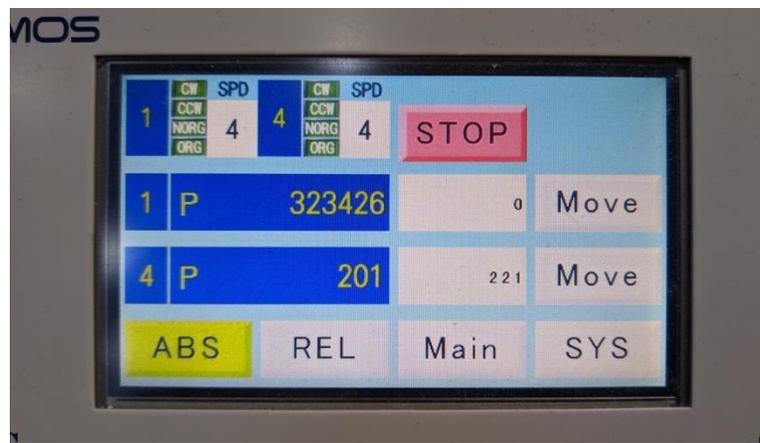
Figure 4 Interface showing input parameters on the handy controller

1. On handy controller, moving main theta (P1/channel 1) to 0 Bragg angle (degrees) by pressing 'ABS' tab (a mode of absolute number) and filling in 0 pulse (Zero) on white part next to the blue P1. Then clicking on 'Move' shown in figure 4.

2. Observing a number on the encoder whilst Bragg angle moves to zero degree.
3. Then turning off and on a switch at back of the encoder.
4. After the encoder is on, pressing 'Enter' button.
5. Observing a number of main theta and red "ref" being blinking on from the encoder.
6. Back to the handy controller, inputting 152,000 pulses on a mode of ABS, you will see the number on encoder runs pass 'ref number' ( $4.15387^\circ$ ). It would assume it perform just fine.
7. Then moving main theta back to  $0^\circ$  again (by filling in 0 pulse on ABS mode)
8. Pressing a blue part on P1 which Channel 1 is relating to main theta to become 0 (zero)
9. Numbers on both encoder and controller will become coincide
